# **Evaluation of Non-Certified ESFR Sprinkler Samples**

**Technical Report by UL LLC**

**International Fire Sprinkler Association**

**Issued January 29, 2015**

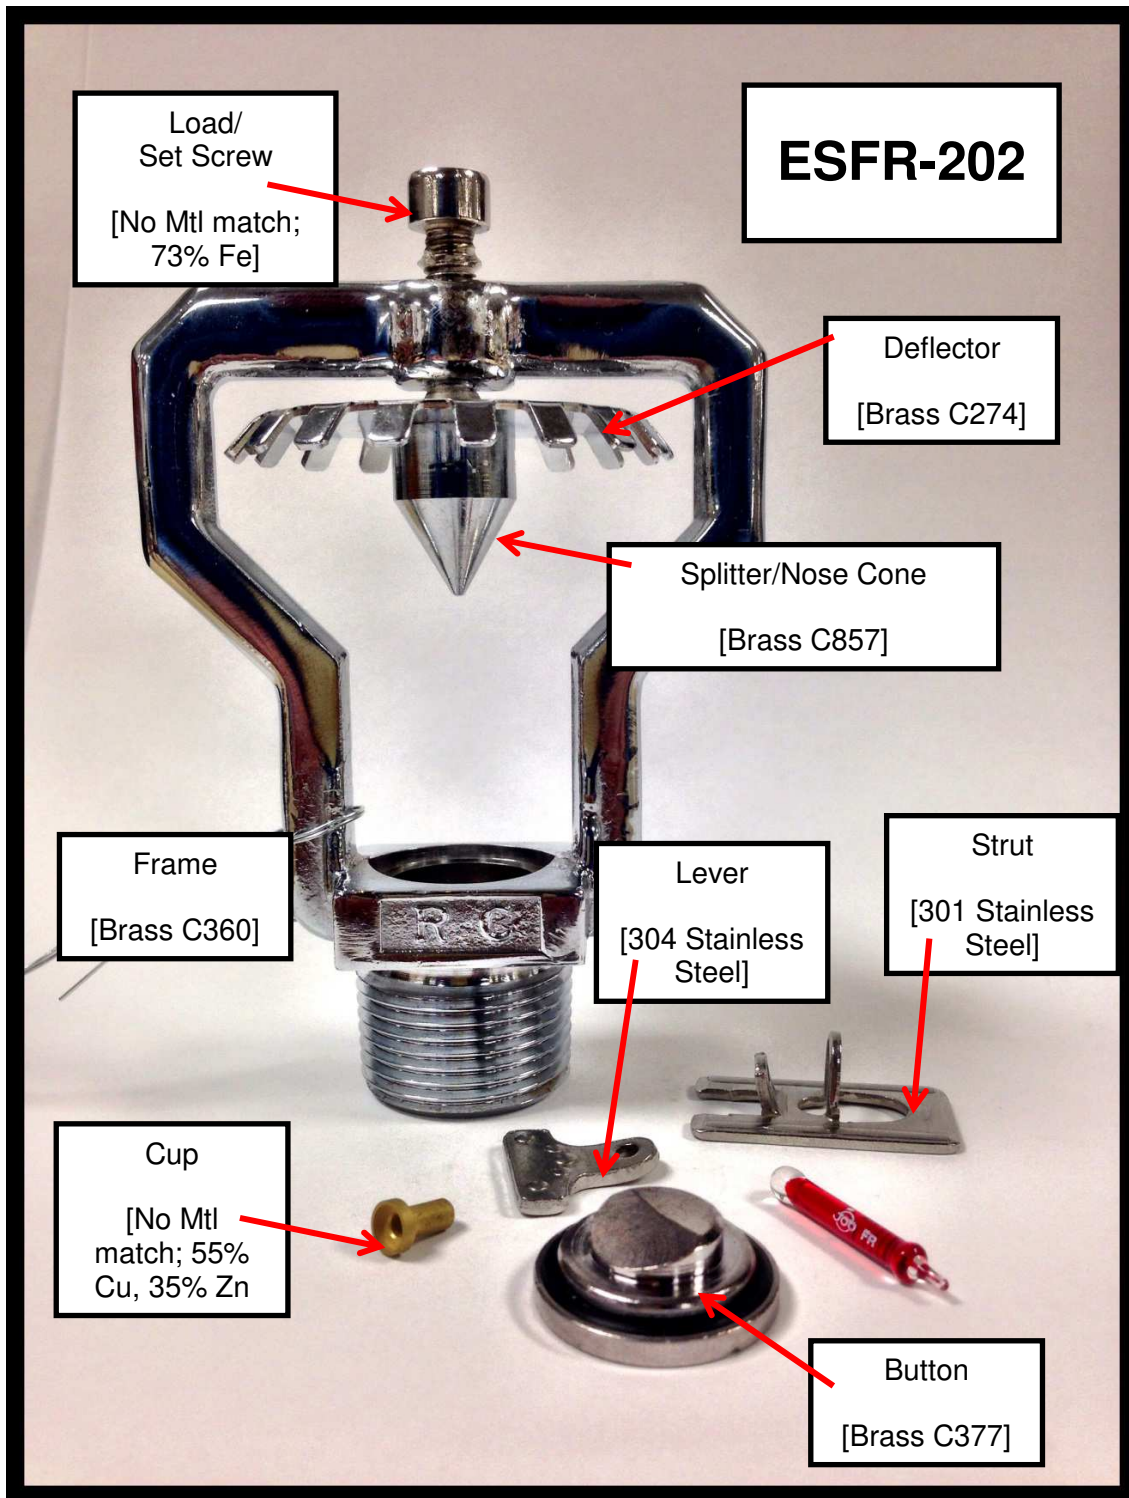
Figure 1 Model ESFR-202, Material Analysis

The closest material match for each sprinkler part is referenced in Figure 1 and Figure 2.

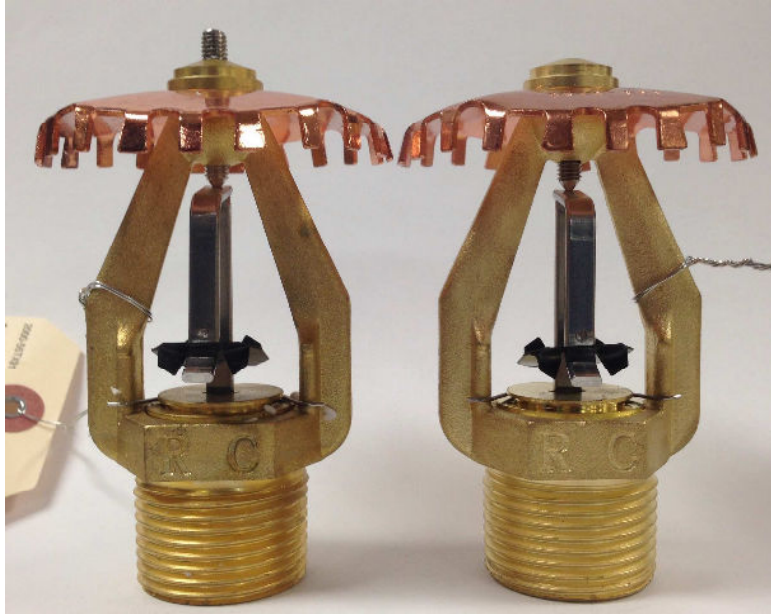
Figure 3 Model ESFR-363 Construction Inconsistencies – Load Screw

The Model ESFR-363 sprinkler samples appeared to be constructed in a similar manner, with the exception of the loading screw lengths. See Figure 3 for an example of the varying difference in length amongst.

During the examination and testing of sprinkler components, it was observed that the loading screw for both sprinkler constructions were removed with relative ease which indicated that they were insufficiently staked to maintain the factory applied load.

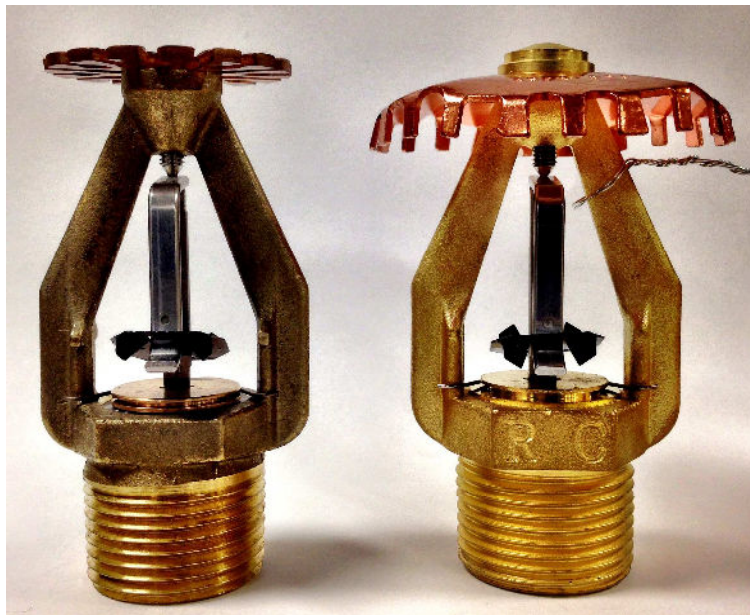
Figure 4 UL Certified ESFR sprinkler (left) vs. ESFR-363 (right) – Deflector

The ESFR-363 sprinkler utilized a deflector construction intended for use on an Extended Coverage Storage sprinkler, not an ESFR sprinkler as marked. See Figure 4 for a visual comparison of a UL certified ESFR sprinkler vs. the submitted ESFR-363.

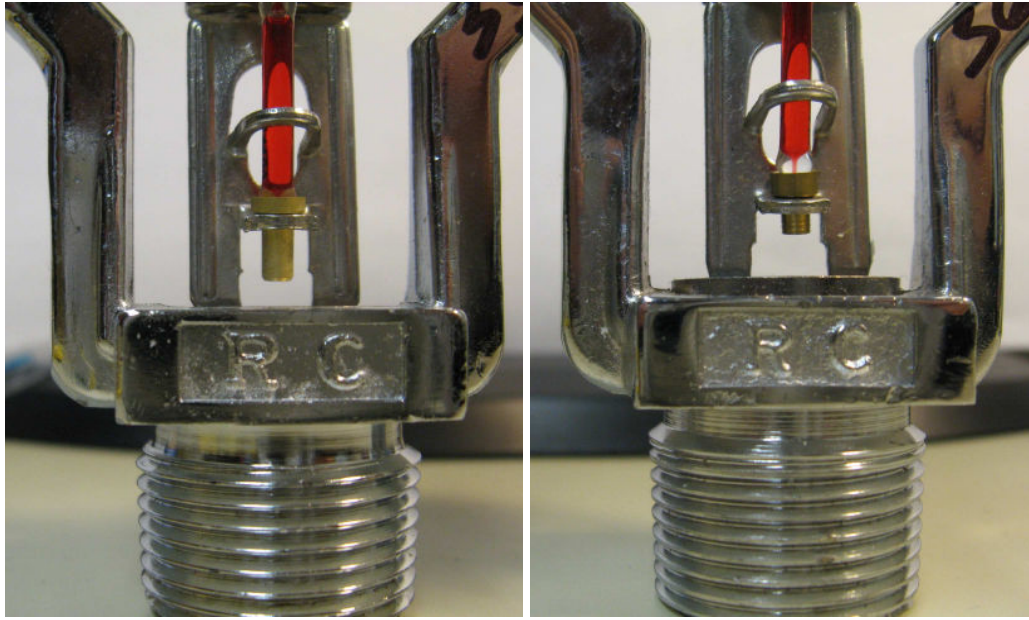
Figure 5 ESFR-202, Construction Inconsistencies – Cup

The Model ESFR-202 sprinkler samples appeared to be constructed in a similar manner, with the exception of the loading screw lengths (similar to that shown in Figure 3) and two different cup constructions (See Figure 5).

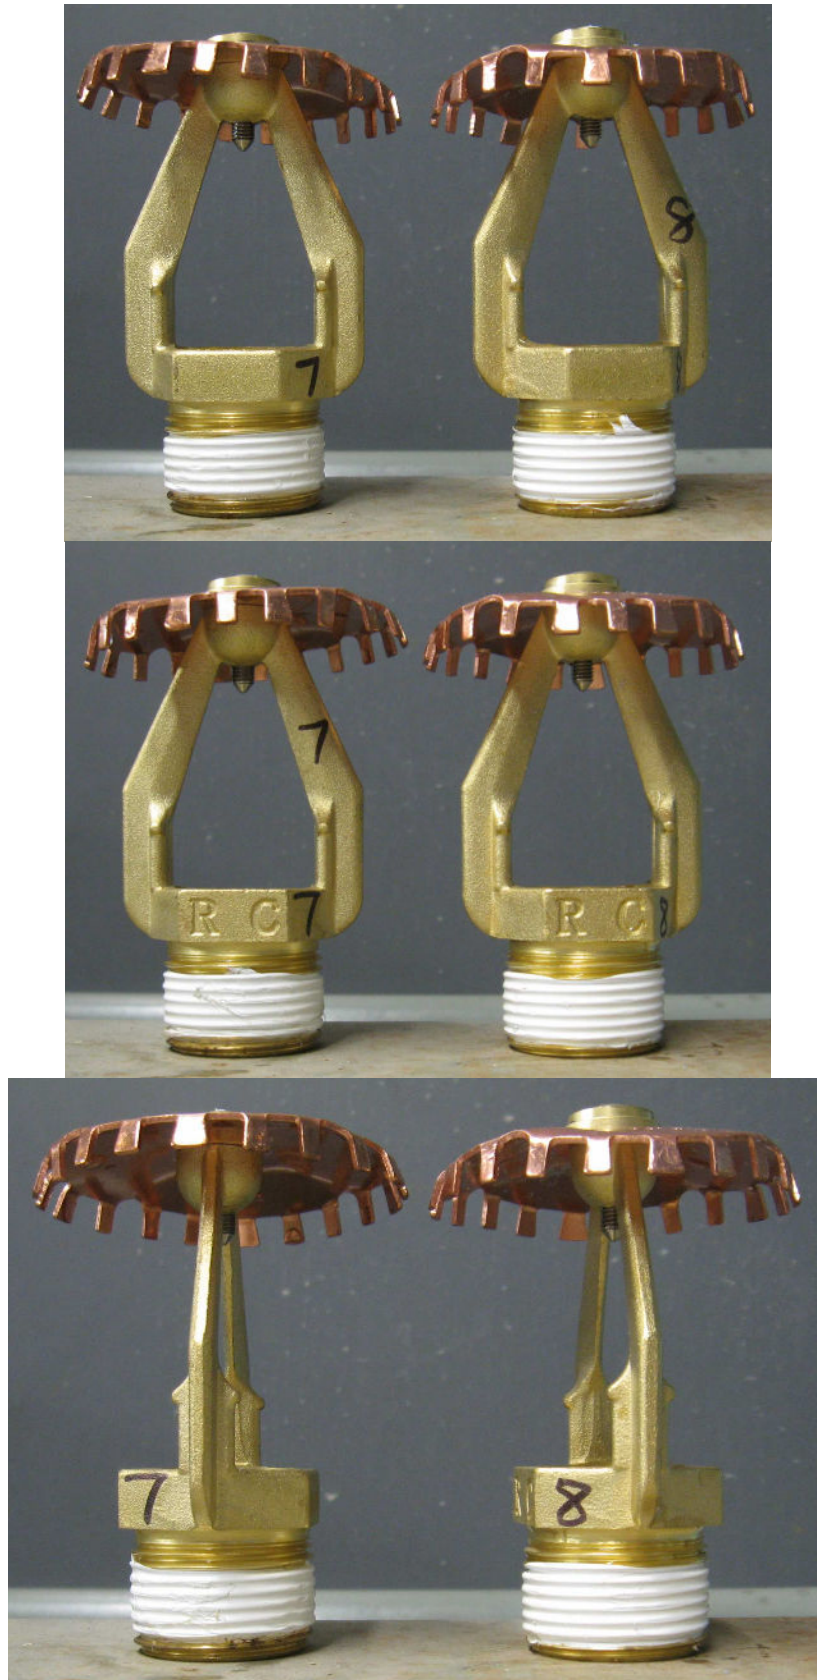
Figure 6 ESFR-363, Post-Flow Endurance Test – Deflector Deformation

Both sprinkler models showed substantial visual deformation as illustrated in the following photos designated as Figure 6 and Figure 7. This deformation significantly altered the distribution characteristics of each sprinkler model.

Note: For comparison purposes, the sprinkler shown on the left side of the photo was subjected to the Flow Endurance Test, while the sprinkler on the right was not.

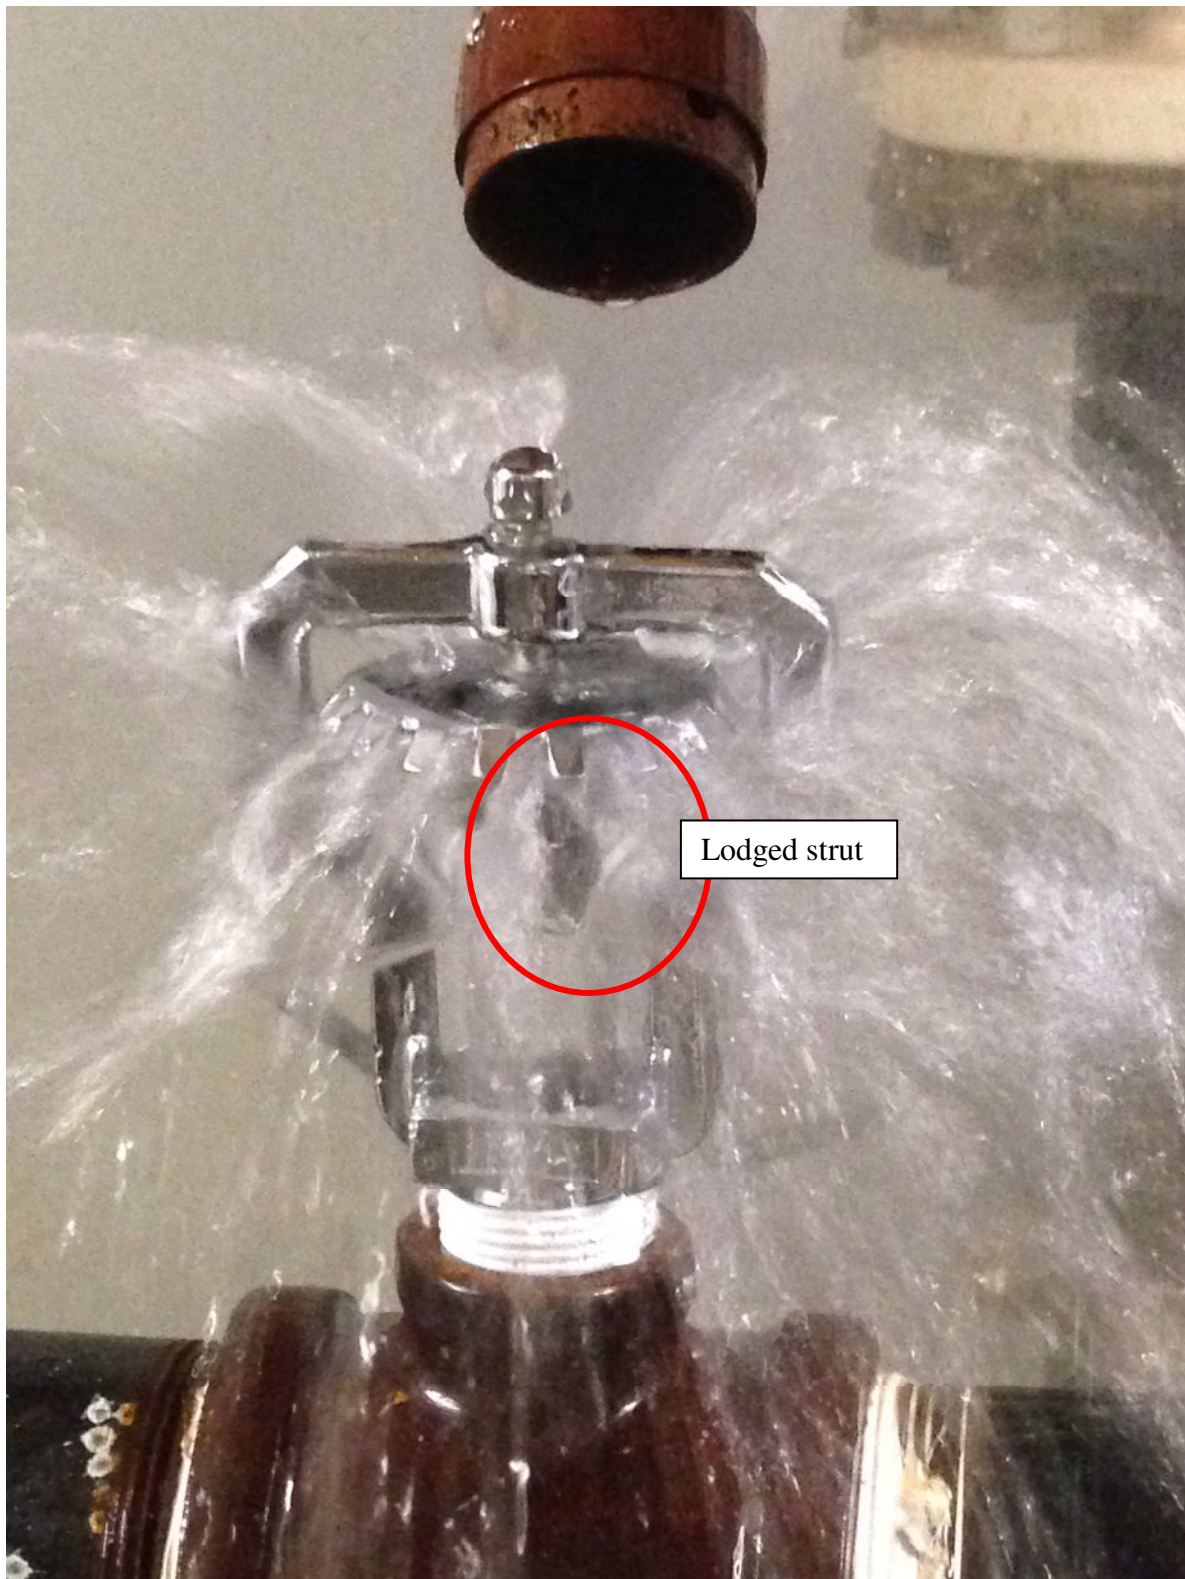
Figure 8 ESFR-202, Non-compliant Lodgment Test

| Sample No. | Sprinkler Identification | Type of Water Supply Feed | Inlet Pressure, bar (psig) | Comments |
|---|---|---|---|---|
| 26 | | Single | 3.4 (50) | The strut lodged on/against the splitter [See Figure 8], negatively impacting the water discharge pattern by causing a large quantity of water to be discharged above the deflector, as depicted in Figure 9. |

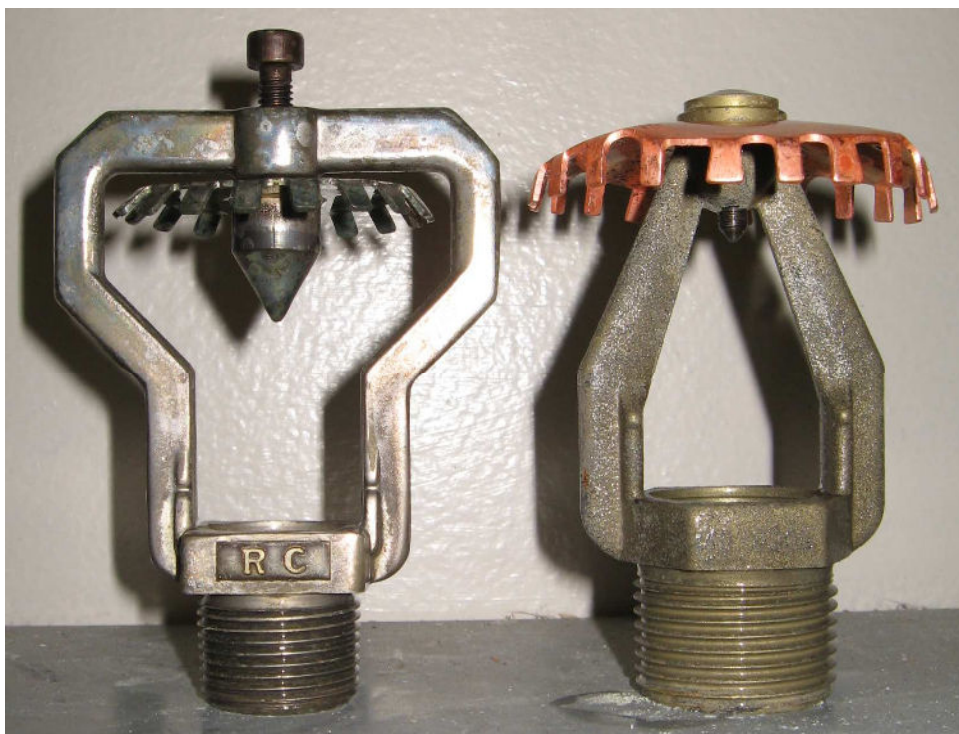
Figure 11 ESFR-202 & ESFR-363 – Post-Heat Resistance Test

The samples withstood the exposure to the heat and subsequent water immersion without significant deformation, blistering, cracking or other damage which would impair its discharge characteristics. See Figure 11 for post-exposure photo of each tested sample.

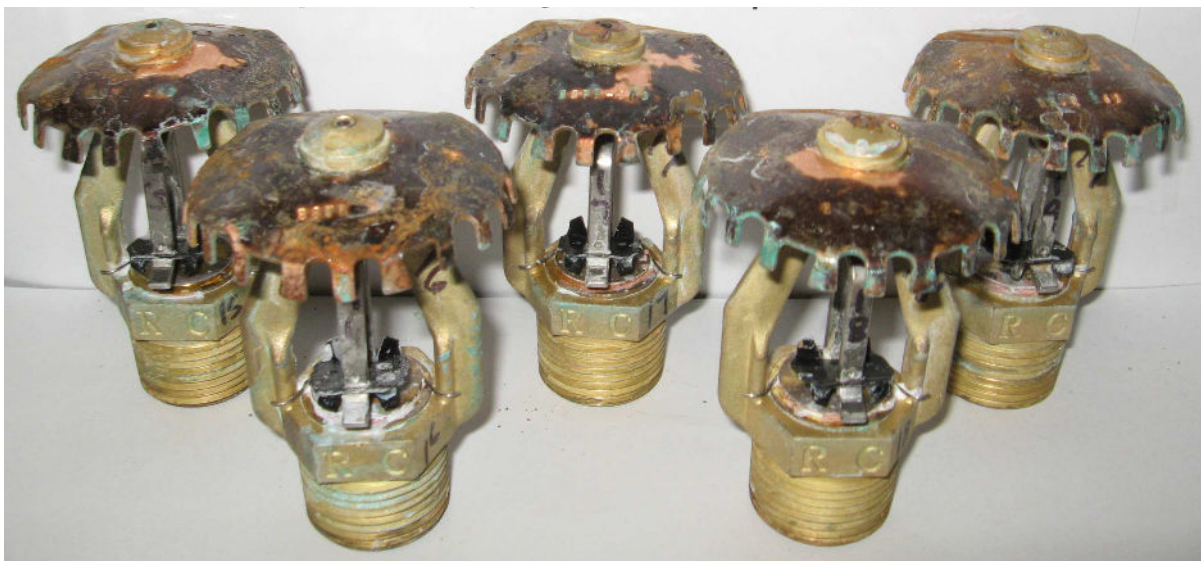
Figure 12 ESFR-363 Post-10-Day Salt Spray Exposure

The Sensitivity Test results are presented in Table 4. See Figure 12 for a post-exposure photo of the sprinklers prior to Sprinkler Sensitivity testing. See Figure 13 for photos of the two sprinklers that did not operate after being subjected to the Sensitivity Test.

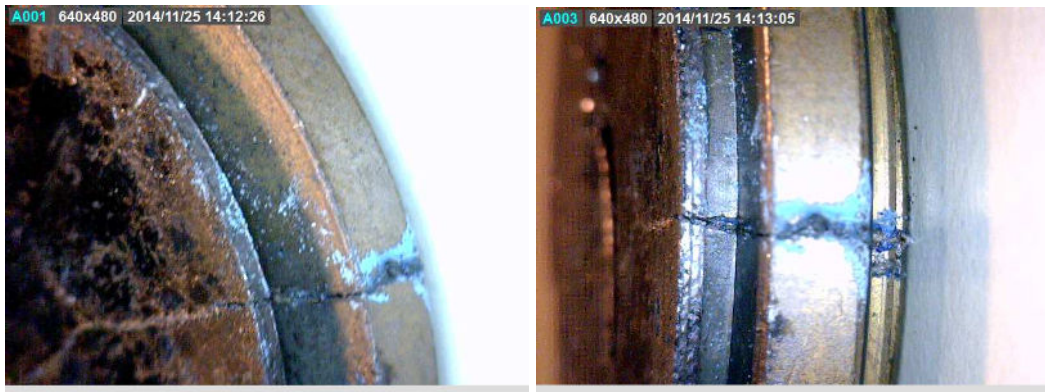
Figure 14 ESFR-363 Button – Images of Post-Stress Corrosion Cracking of Brass Parts Test

| Sample No. | Sprinkler Identification | Brass Component Tested | Comments |
|---|---|---|---|
| | | Button | Cracking observed. See Figure 14 for 25x magnified image confirming cracking. |

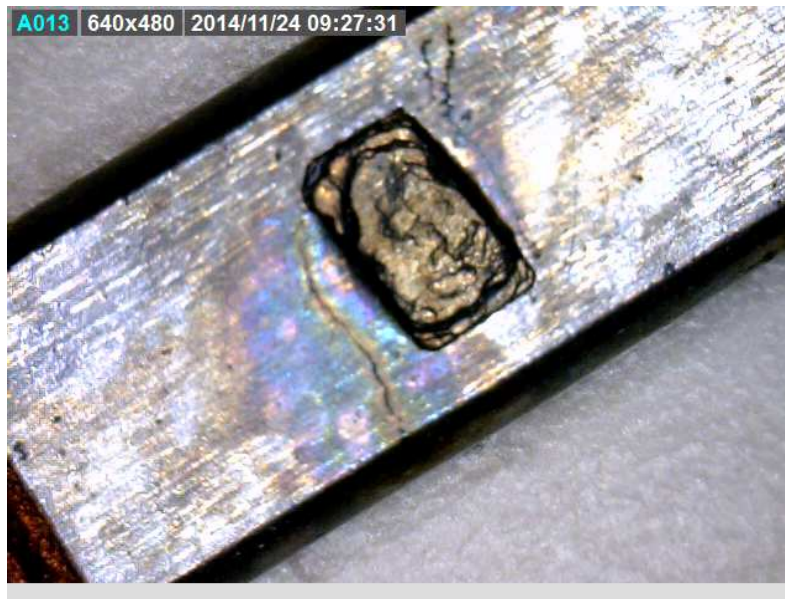
Figure 15 ESFR-363 Strut – Images of Post-Stress Corrosion Cracking of Stainless Steel Parts Test

| Sample No. | Sprinkler Identification | Stainless Steel Component Tested | Comments |
|---|---|---|---|
| 3 | ESFR-363 | Strut | Cracking observed. See Figure 15 for 25x magnified image confirming cracking. |
