**Evaluation of Model ZSTX-15 SSP and ZSTZ-15 SSU  
Non-Certified Sprinkler Samples**

**Technical Report by UL LLC**

**International Fire Sprinkler Association**

**Issued: June 10, 2016**

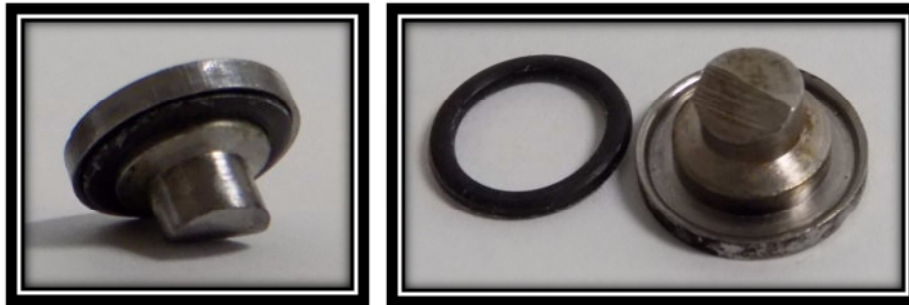
Figure 3 O-ring Seal

Both the Models ZSTX-15 pendent and ZSTZ-15 sprinklers utilized a dynamic O-ring type water seal, as shown in Figure 3, which has not been permitted in ANSI/UL 199 since January 9, 2003.

1. **O-ring Water Seals** – Both sprinkler constructions utilized an O-ring style water seal assembly. O-rings have not been permitted in UL certified sprinkler constructions since January 9, 2003 due to the potential for this type of water seal construction to leak or not permit the discharge of water from a sprinkler after exposure to field installation environments. Previous UL research indicated that elastomeric O-ring water seals used in sprinklers have the potential to adhere to the mating surface and are susceptible to the collection of corrosion and other products in the small annular spaces between the operating parts causing inhibited sprinkler operation. The following link provides an example of a product recall issued on O-ring sealed sprinklers: <http://www.cpsc.gov/en/recalls/2001/cpsc-central-sprinkler-company-announce-voluntary-recall-to-replace-o-ring-fire-sprinklers/>

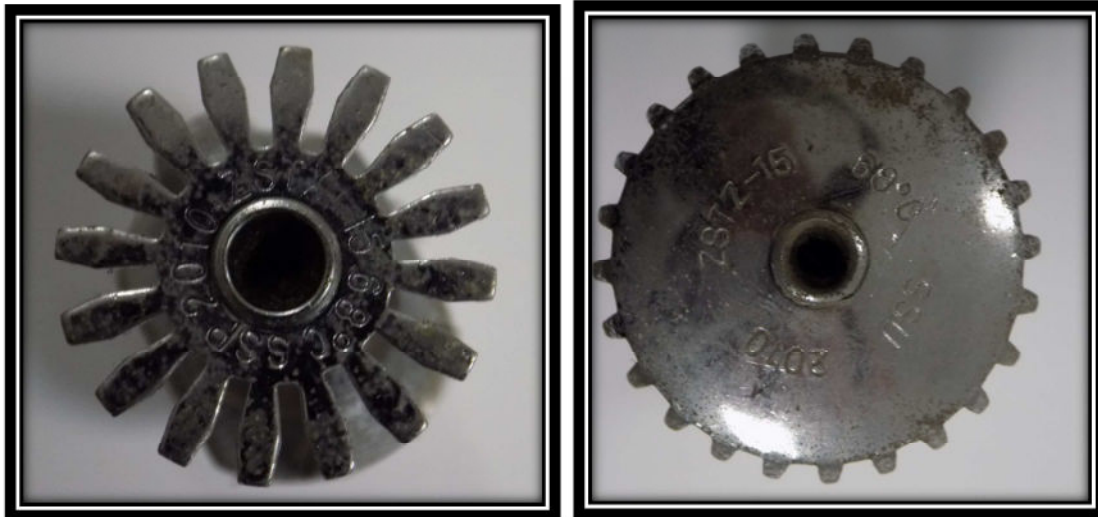
Figure 5 Deflector Markings

The pendent sprinkler construction was marked “ZSTX-15 68°C SSP 2010,” suggesting the sprinkler. The upright sprinkler construction was marked “ZSTZ-15 68°C SSU 2010”. In addition, the wrench boss of both the pendent and upright constructions were marked with “P A” on one side. See Figure 5 and Figure 6 for all markings.

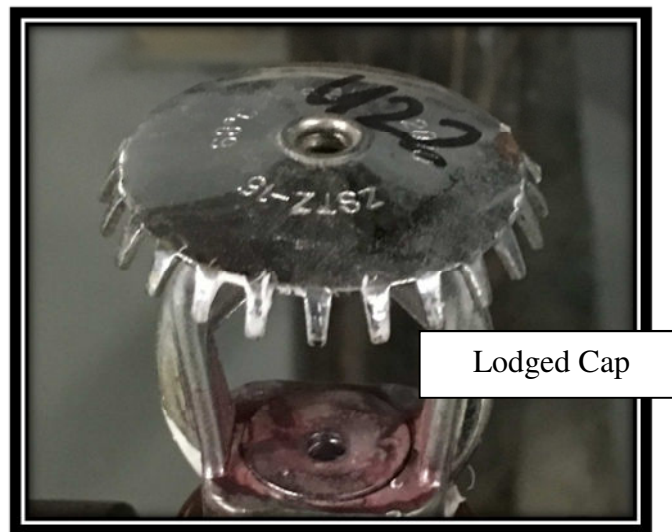
Figure 7 Sample U22 – Single Feed Upright, Non-compliant Lodgment Test

| Sample Nos. | Sprinkler Identification | Inlet Pressure, bar (psig) | Comments |
|---|---|---|---|
| U22 | | 0.5 (7) | DNO [See Figure 7] |

DNO – Glass bulb operated, but the water seal did not release with the applied water pressure of 0.5 bar (7 psig). Subsequently, the sprinkler was subjected to a gradually increasing water inlet pressure to determine the pressure required to release the water seal. For sample U22, this pressure was 2.34 bar (34 psig).

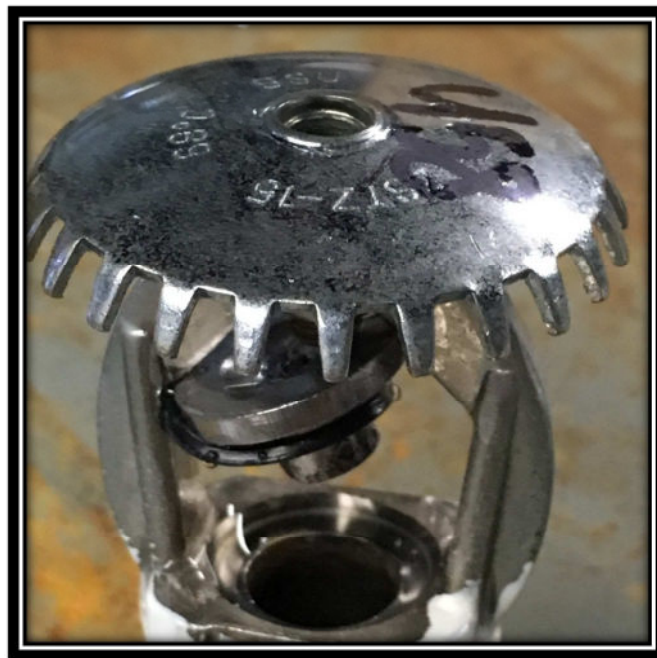
Figure 9 Sample U58 – Single Feed Upright, Non-compliant Lodgment Test

| Sample Nos. | Sprinkler Identification | Inlet Pressure, bar (psig) | Comments |
|---|---|---|---|
| U58 | | 12.1 (175) | The cap lodged on the frame arms, adversely impacting the water discharge pattern[See Figure 9] |

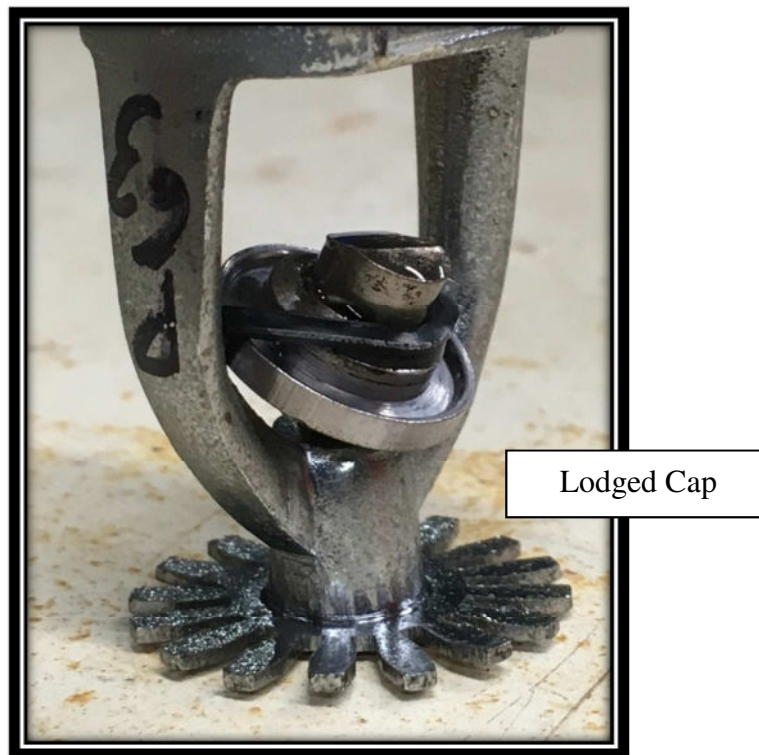
Figure 10 Sample P63 – Double Feed Pendent, Non-compliant Lodgment Test

| Sample Nos. | Sprinkler Identification | Inlet Pressure, bar (psig) | Comments |
|---|---|---|---|
| P63 | | | The cap lodged on the set screw, adversely impacting the water discharge pattern [See Figure 10] |

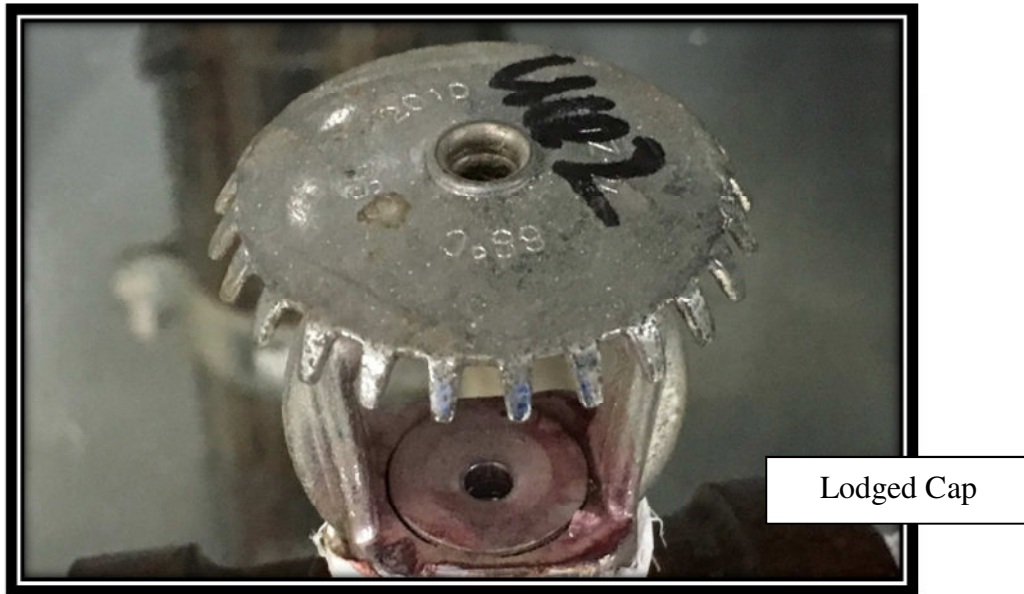
Figure 11 Sample U62 – Double Feed Upright, Non-compliant Lodgment Test

| Sample Nos. | Sprinkler Identification | Inlet Pressure, bar (psig) | Comments |
|---|---|---|---|
| U62 | | | DNO [See Figure 11] |

DNO – Glass bulb operated, but the water seal did not release with the applied water pressure of 0.5 bar (7 psig). Subsequently, the sprinkler was subjected to a gradually increasing water inlet pressure to determine the pressure required to release the water seal. For sample U62, this pressure was 2.14 bar (31 psig).

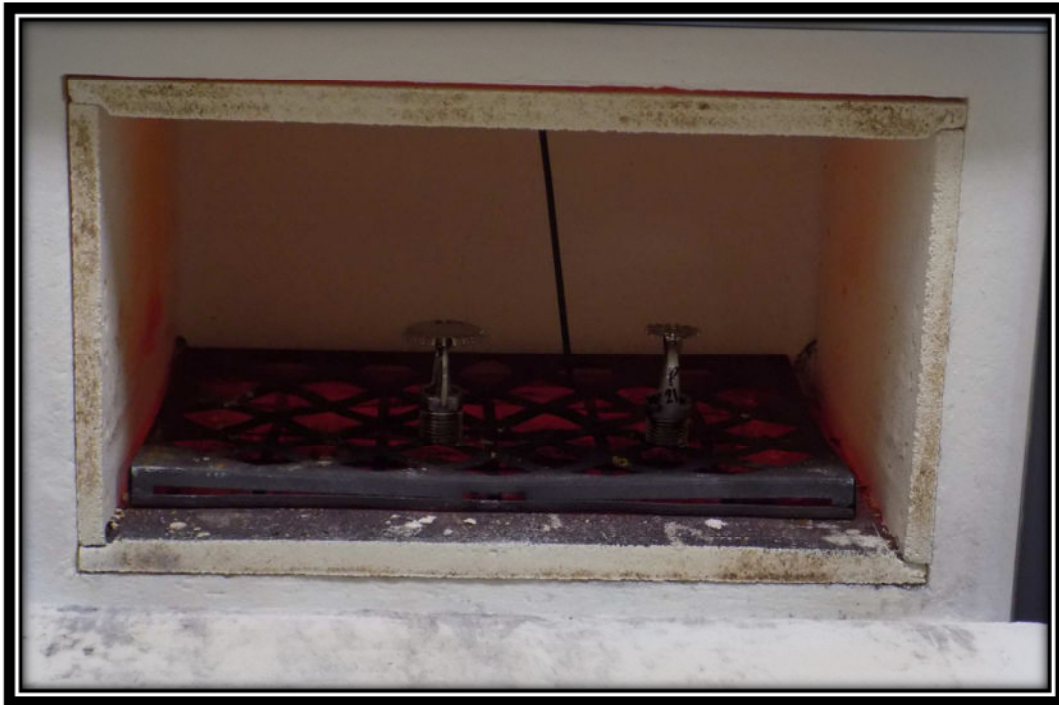
Figure 15 Heat Resistance Samples – Test Set Up

Two samples of each of the Model ZSTX-15 pendent and ZSTZ-15 upright sprinklers, without operating parts, were placed vertically on their inlet in an oven heated to  $650 \pm 10^{\circ}\text{C}$  ( $1200 \pm 20^{\circ}\text{F}$ ) for 15 minutes, as shown in Figure 15. Following this exposure, each sample was removed from the oven and immediately submersed in a water bath having a temperature of  $15 \pm 6^{\circ}\text{C}$  ( $60 \pm 10^{\circ}\text{F}$ ). The samples were then examined for signs of fracture, deformation, or other damage, as specified in ANSI/UL 199.

The samples withstood the exposure to the heat and subsequent water immersion without significant deformation, blistering, cracking or other damage which would impair its discharge characteristics.
