# **Evaluation of Non-Certified ESFR Sprinkler Samples**

**Technical Report by UL LLC**

**International Fire Sprinkler Association**

**Issued January 29, 2015**

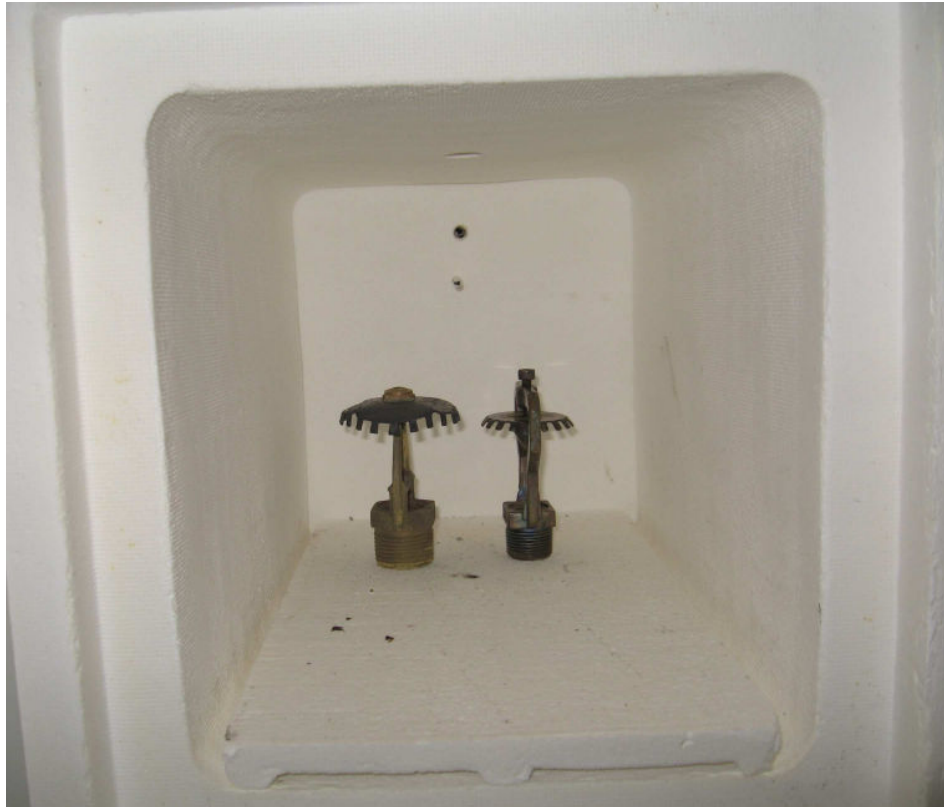
Figure 10 Heat Resistance Samples – Test Set-Up

One sample of each of the Model ESFR-363 and ESFR-202 sprinklers, without operating parts, was placed vertically on its inlet in an oven heated to  $650 \pm 10^{\circ}\text{C}$  ( $1200 \pm 20^{\circ}\text{F}$ ) for 15 minutes, as shown in Figure 10. Following this exposure, each sample was removed from the oven and immediately submersed in a water bath having a temperature of  $15 \pm 6^{\circ}\text{C}$  ( $60 \pm 10^{\circ}\text{F}$ ). The samples were then examined for signs of fracture, deformation, or other damage, as specified in ANSI/UL 1767.
